PROJECT PROFILE

SMITHSONIAN BUTTERFLY HOUSE

DESIGN Cocoon shaped resin and aluminum enclosure simulating a butterfly habitat. A 45 mil reinforced polypropylene geomembrane installed by Hallaton as a containment system and liquid barrier for the Butterfly House's planter and flooring system.

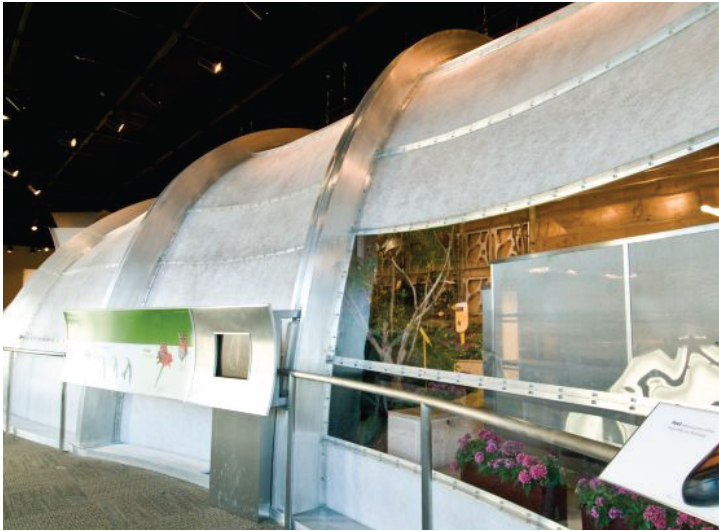
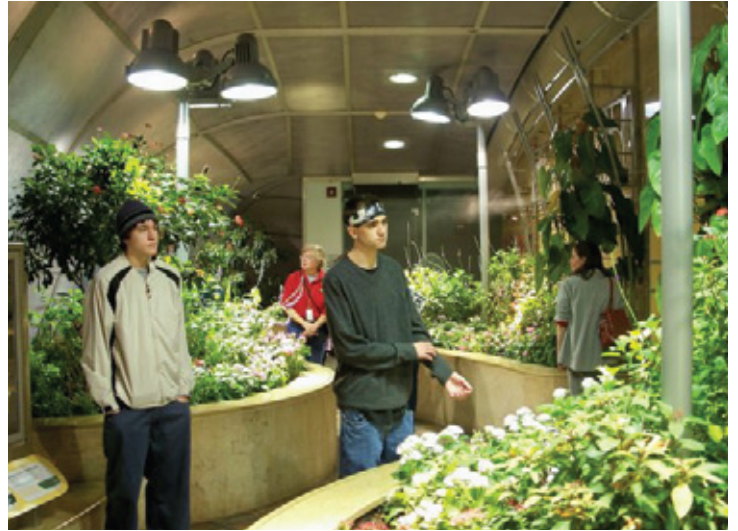
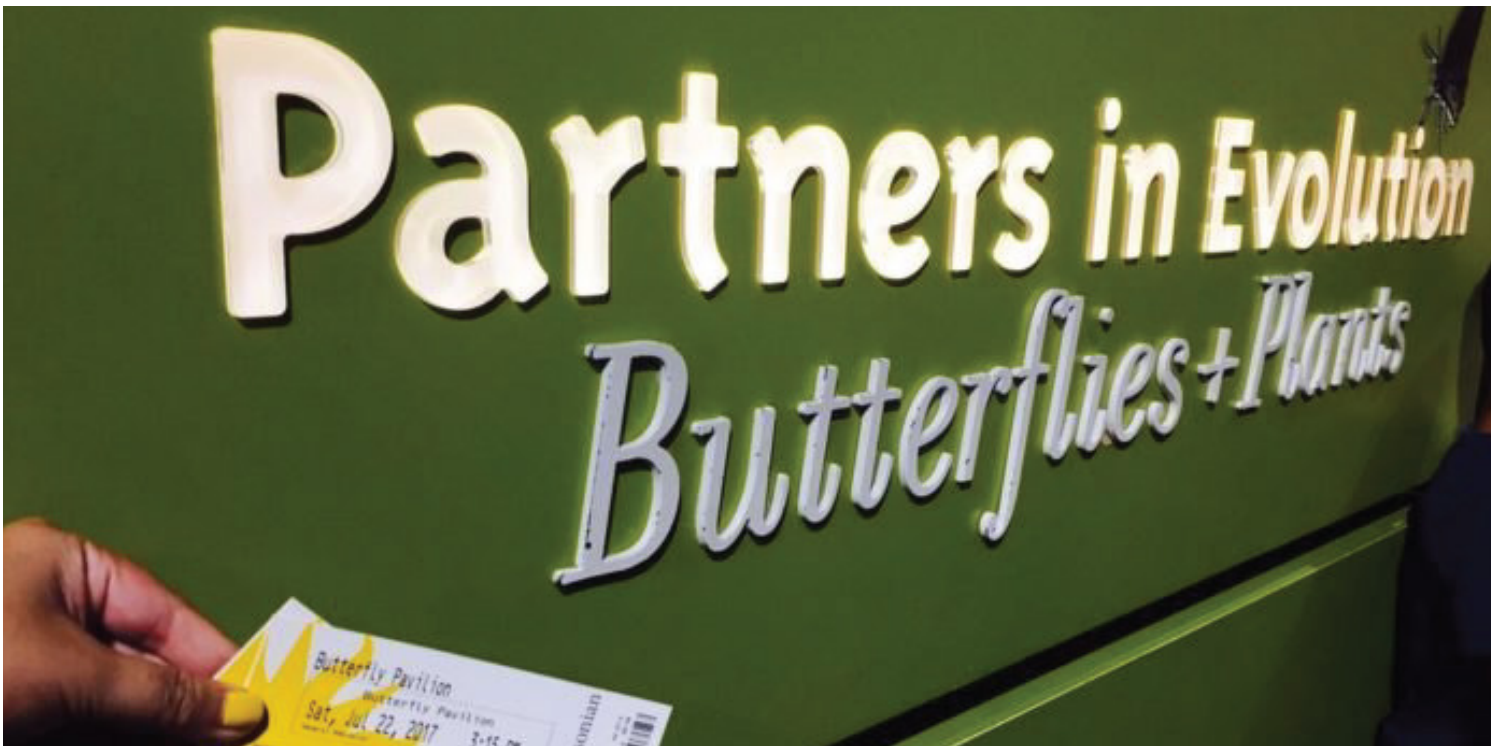
Hallaton's critical work of furnishing and installing the liner system included wedge and /or hot air welding all seams, attaching the liner to various structures, and performing field testing and quality control. Upon completion of the installation, the liner system was completely flooded as a final test for any previously undetected leaks.

The lined floor received 4" of concrete with a final mortar and tile surface. The lined planter walls received a rock facing treatment, and the interiors were covered with various natural materials such as moss, lava rock and plantings to create a natural environment for the butterflies.

The exhibit's curved walls and curved planter structures provided challenges in the installation process for Hallaton as they cut and seamed rectangular, rolled geomembrane to fit as tightly as possible and with as little seaming as possible. The lining system successfully protects the lower levels of the museum beneath the new Butterfly House.
